## KEEPING YOUR 513-385-8526 KEEPING YOUR SIGNALS STRAIGHT

THE TURN SIGNAL HOUSING ON my 1959 Corvette has always been loosening. Once that occurred, the canceling mechanism along with the turn signals would no longer function properly. I took the steering wheel off

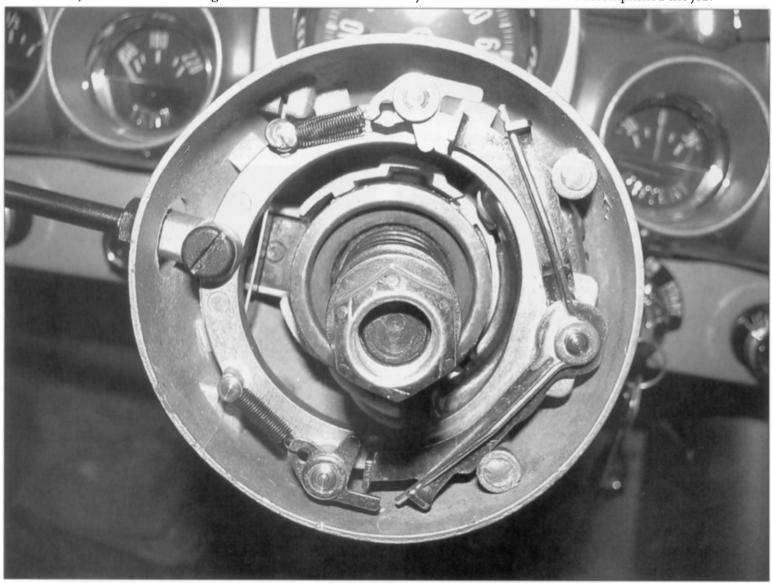
First take your horn button and horn contact off. Next use a steering wheel puller to remove the steering wheel. Please don't try to accomplish this without a puller, it can be done but you take great chances in damaging your wheel or your hub. In this photo, you can now see the canceling mechanism in the turn signal housing. By the way, this would also be a great time to fix the canceling mechanism and/or the turn signal switch.

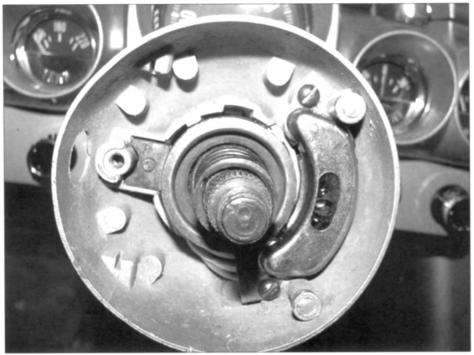
Remove the canceling mechanism exposing the sliding friction nut (the piece you need to work on). The sliding friction nut grips as you tighten the Phillips screw on the housing. Because it is fitted to a smooth, aluminum component, minor loosening causes the friction nut to fail. The housing can then rotate and move up and down the column.

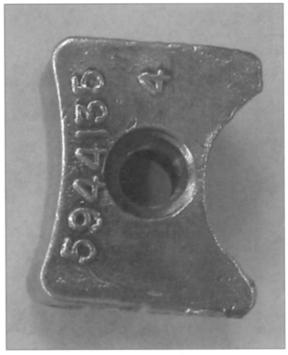
Next, take the nut and screw out. Here's the troublemaker, removed from the steering column assembly. At this point, you can clean it up.

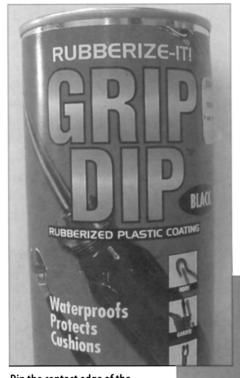
Dip the contact edge of the nut partially into a rubberized coating solution. I use Grip Dip but there are plenty of others available (second photo). You may want to dip it twice to get a slightly thicker coating. Then hang the nut to dry for 24 hours.

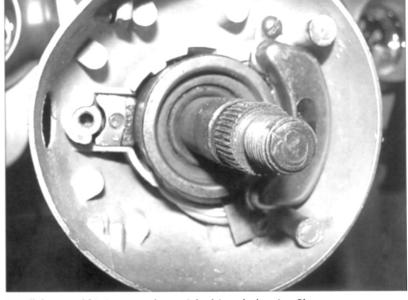
Install the coated friction nut and screw it back into the housing. Place it where you need it, tighten it and you won't need to tighten it again. The increased friction of the now attached rubber firmly grips the smooth painted surface so that even small amounts of pressure will hold it firm. Reassemble the canceling mechanism, and replace the steering wheel and horn button and you're ready to enjoy many miles of Corvette driving with signal lamps that cancel again!
